REPORT OF INVESTIGATION
UNDERGROUND MINE COAL DUST EXPLOSION

No. 11 Mine (ID No. 15-02290)
Adkins Coal Company
Kite, Knott County, Kentucky

December 7, 1981

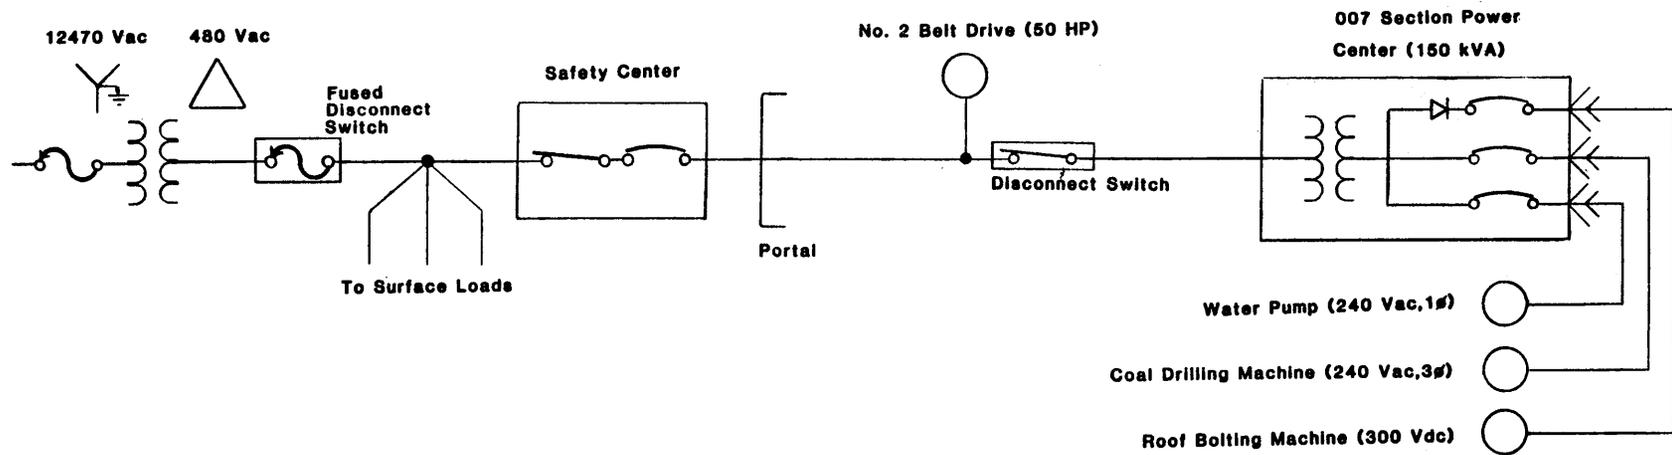
APPENDIX D
 No. 11 MINE I.D. No. 15-02290
 ADKINS COAL COMPANY

ONE-LINE DIAGRAM OF UNDERGROUND DISTRIBUTION
 CIRCUIT AT TIME OF THE EXPLOSION
