**United States
Department of Labor
Mine Safety and Health Administration
Office of the Administrator
Coal Mine Safety and Health**

**Report of Investigation
Underground Coal Mine Explosion
Dutch Creek No. 1 Mine – I.D. No. 05-00301
Mid-Continent Resources, Inc.
Redstone, Pitkin County, Colorado
April 15, 1981**

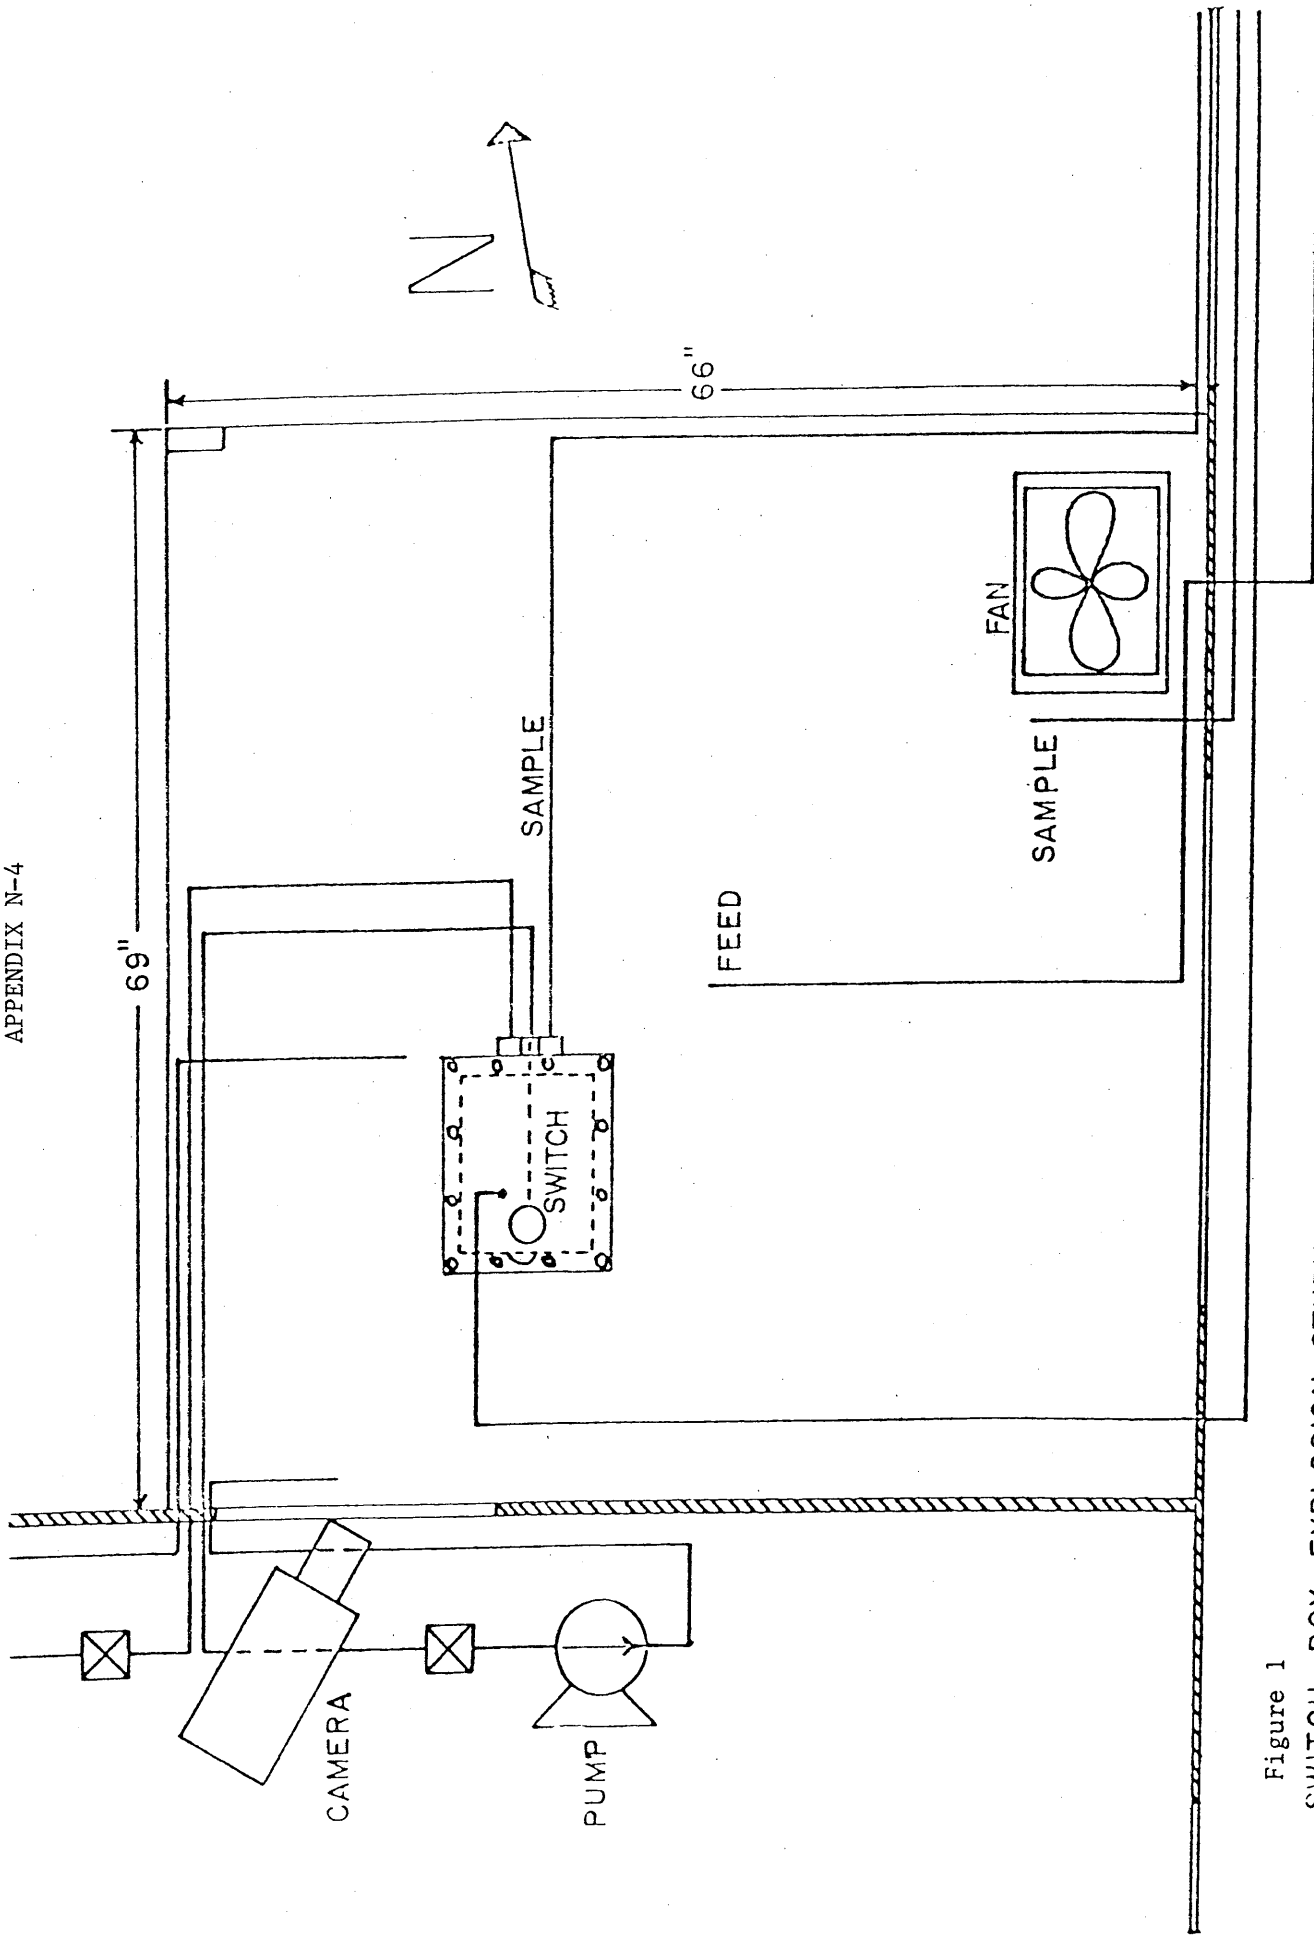
Figure 1
 SWITCH BOX EXPLOSION STUDY
 TEST SET-UP
 SCALE: 1"=1'
 6-2-81
 TMF

A small partition was assembled in the Division's Gas Gallery and used for both regimes. Details of the partition are shown in Figure 1. The height of the

Regime 1: Ignition of the mixture within the box was achieved remotely by either an electric squib or capacitively discharged high-energy spark. Tests were conducted with both original and duplicate boxes. A section of No. 14 stranded wire was placed on the box between the cover plate and box lip. The wire location can be seen in Figure 1 on the south side of the box between the second and third bolts. Gap sizes, ignition source, energy and location, percent methane, and coal dust on flange were all varied in an attempt to propagate an external ignition from an ignition inside the box. Test results are detailed in Table 1.

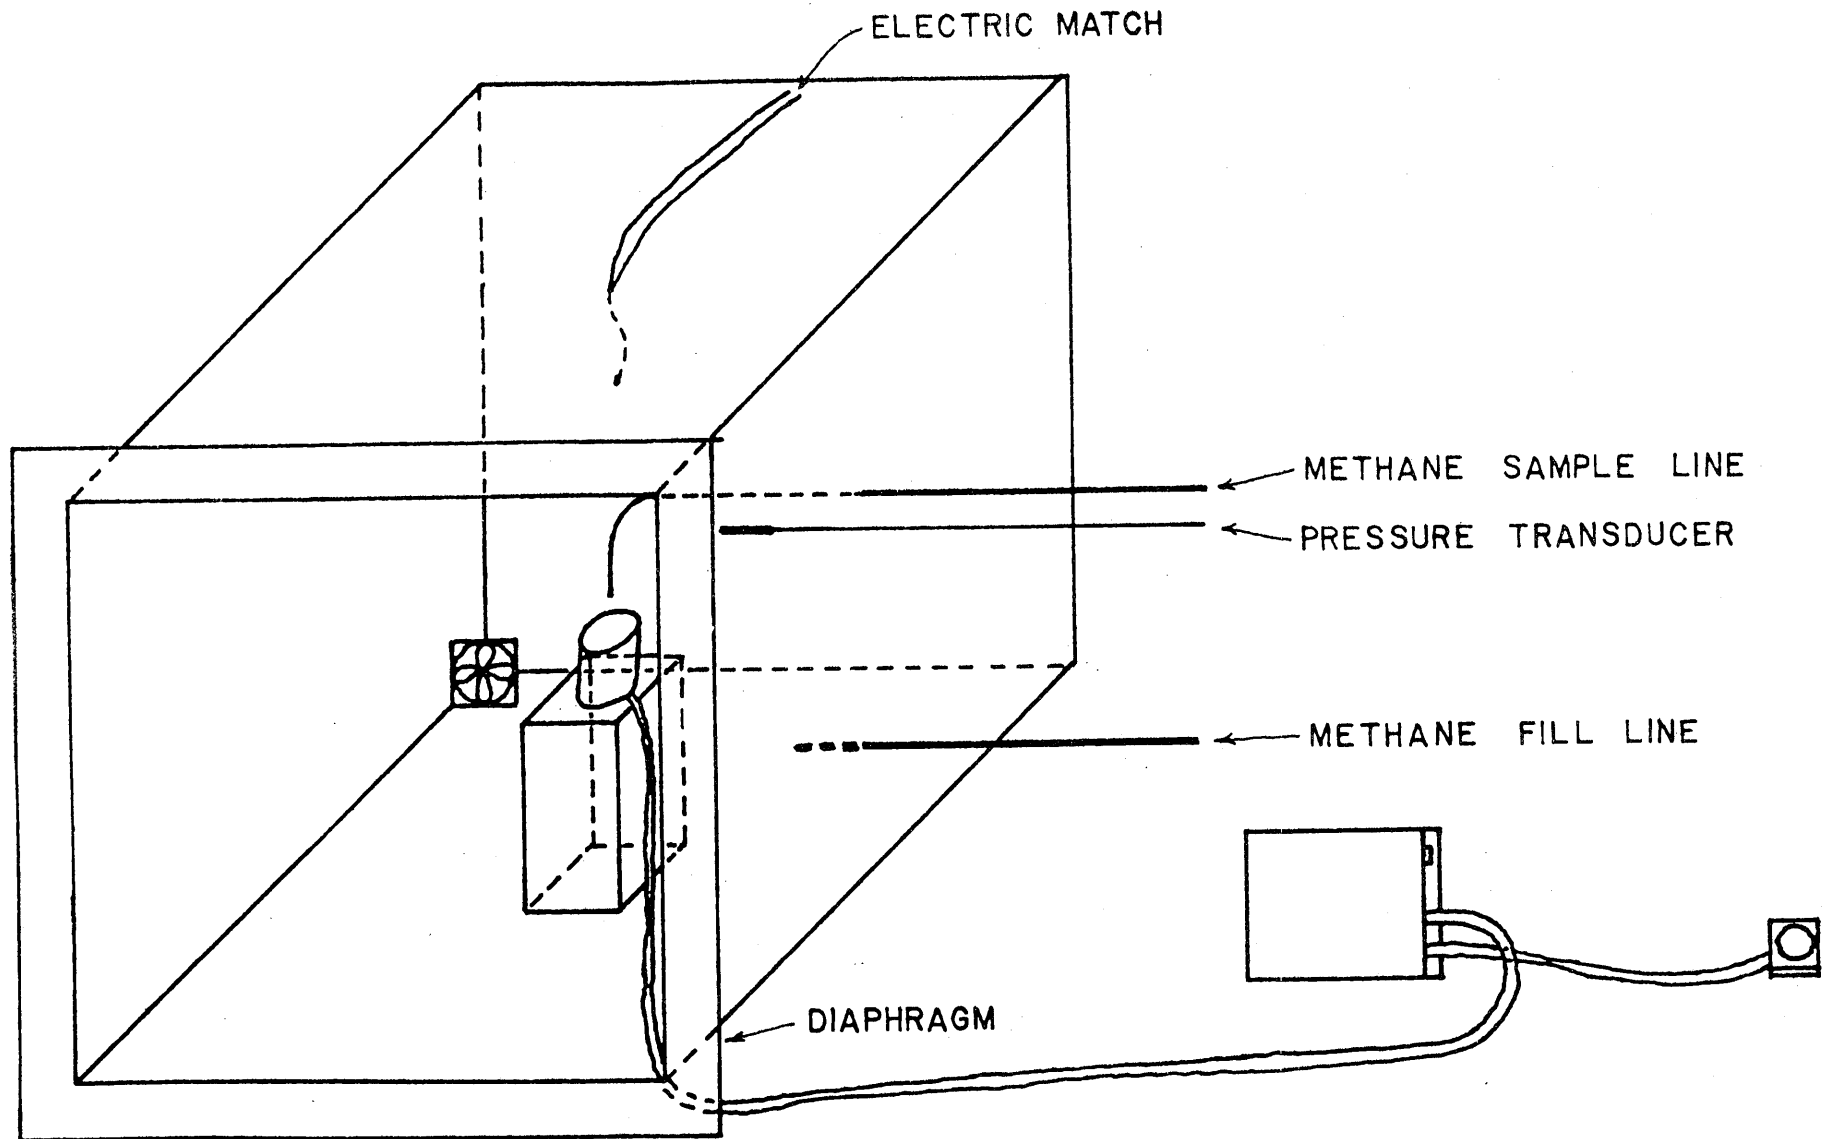
FIG. 1

plastic diaphragm was placed over the open end of the gallery to confine the flammable methane mixture. This diaphragm was 16 square feet in area and provided adequate venting so that maximum explosion pressures were reduced to below 2.0 inches water gage. Ignition was achieved by remotely igniting an electric match placed in the gallery. Figure 1 shows the test configuration.

Further testing would be necessary to determine the actual number of exposures and conditions necessary to initiate degradation. Physical wear, temperature, and humidity are also factors which may play an important part in this determination.
