REPORT OF INVESTIGATION

Fall of Highwall Double Fatality
October 28, 2011

Equality Mine
Armstrong Coal Company Inc.
Centertown, Ohio County, Kentucky
ID No. 15-19344

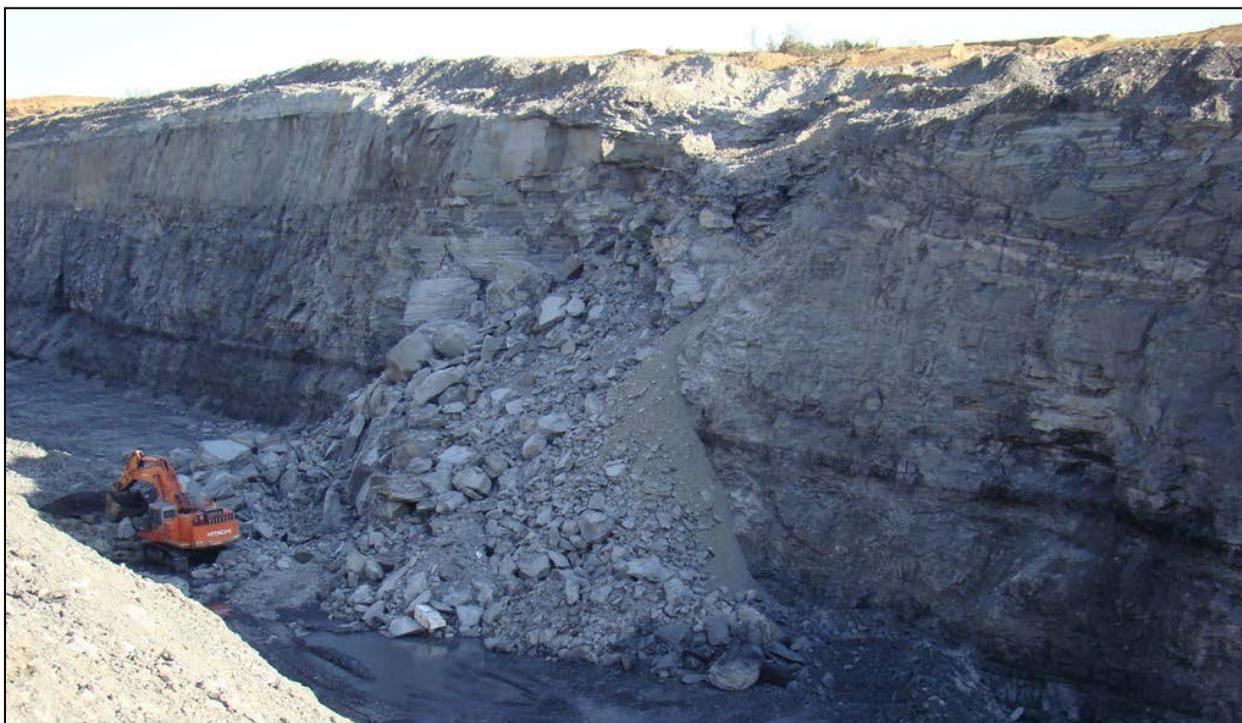
On Friday, October 28, 2011, at approximately 6:15 a.m., 47-year old Darrel Alan Winstead, Certified Blaster, and 23-year old Samuel Joe Lindsey, Blaster Helper, were killed when the 1-ton truck they were in was struck and covered by rock and rubble when a portion of the highwall failed. Both miners were employees of Mine Equipment and Mill Supply Company (MEMSCO), a contractor blasting company for Armstrong Coal Company, Inc. The two miners were in the #11 Pit traveling to the area of the pit that had been prepared for the loading of explosives and the eventual blasting of material as part of normal mining activity when the highwall failure occurred. The accident occurred because mine management failed to recognize a geologic anomaly, located in the portion of the highwall below the #14 coal seam and above the #13 coal seam, prior to the highwall failure.
