REPORT OF INVESTIGATION

Surface Nonmetal Mine
(Sand and Gravel)

Fatal Inundation Accident
June 3, 2016

Harmony Mine & Mill
Green Brothers Gravel Company, Inc.
Crystal Springs, Copiah County, Mississippi
ID No. 22-00650

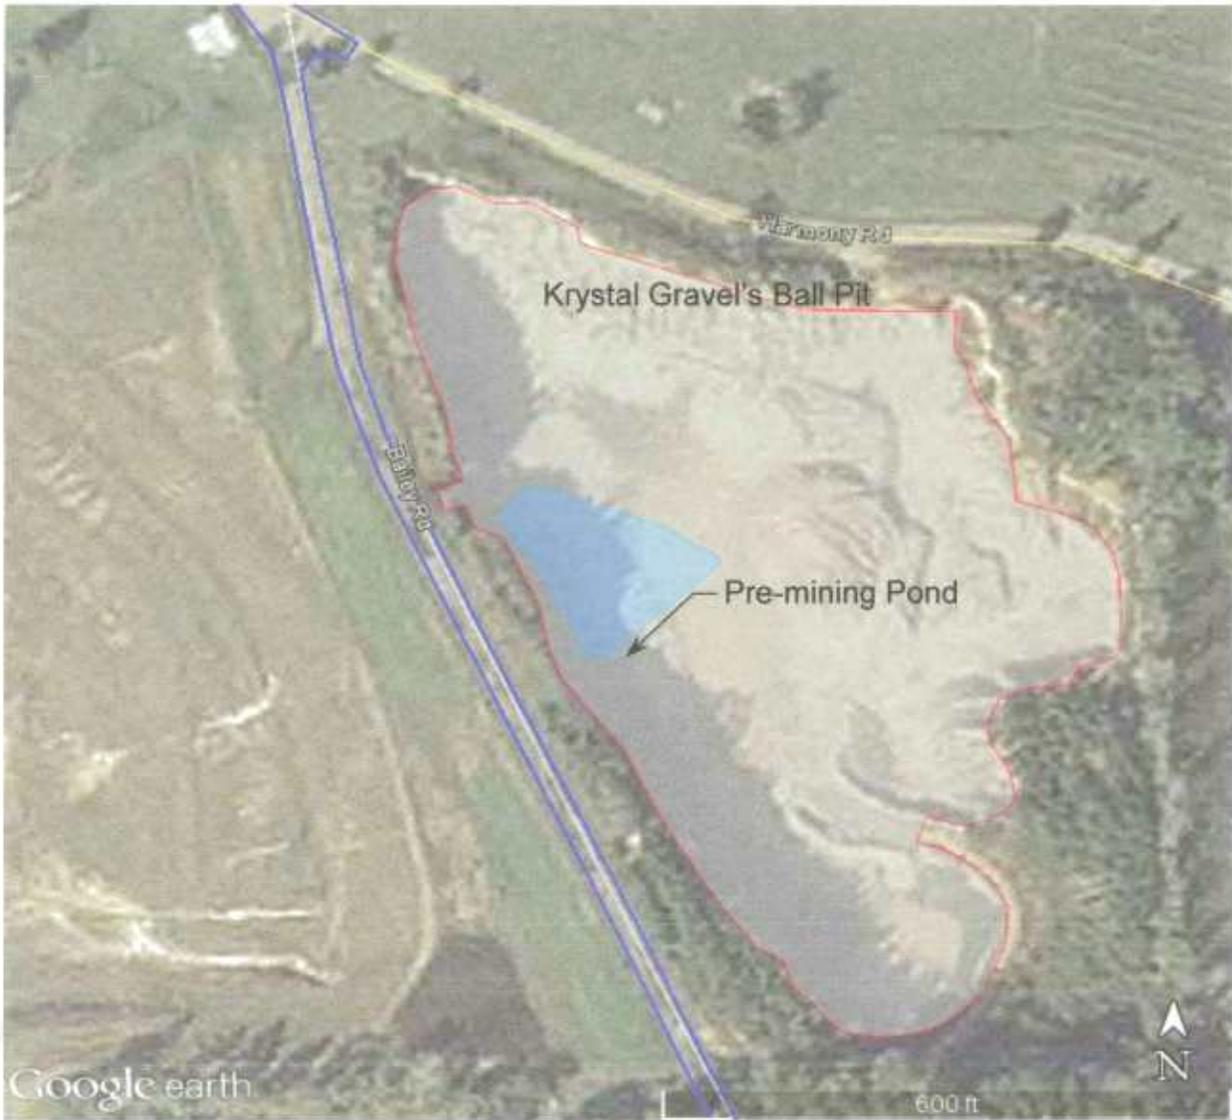
Prior to mining, Green Brothers reportedly stripped about 5 to 6 feet of overburden from the proposed footprint of the Johnson Pit, including old Bailey Road. Most of this overburden material was stockpiled for topsoil cover and the remaining 1 to 2 feet of overburden was pushed into the Ball Pit impoundment along the western shoreline, which was immediately adjacent to and parallel with old Bailey Road. This stripping work removed the pipeline previously used to pump water from the impoundment to the fresh water pond. The footprint of the Johnson Pit during its early development is depicted in Figure 4.

Figure 4 – Location of Krystal Gravel's Ball Pit and old Bailey Road shown on a satellite image dated November 4, 2004, viewed in Google earth.

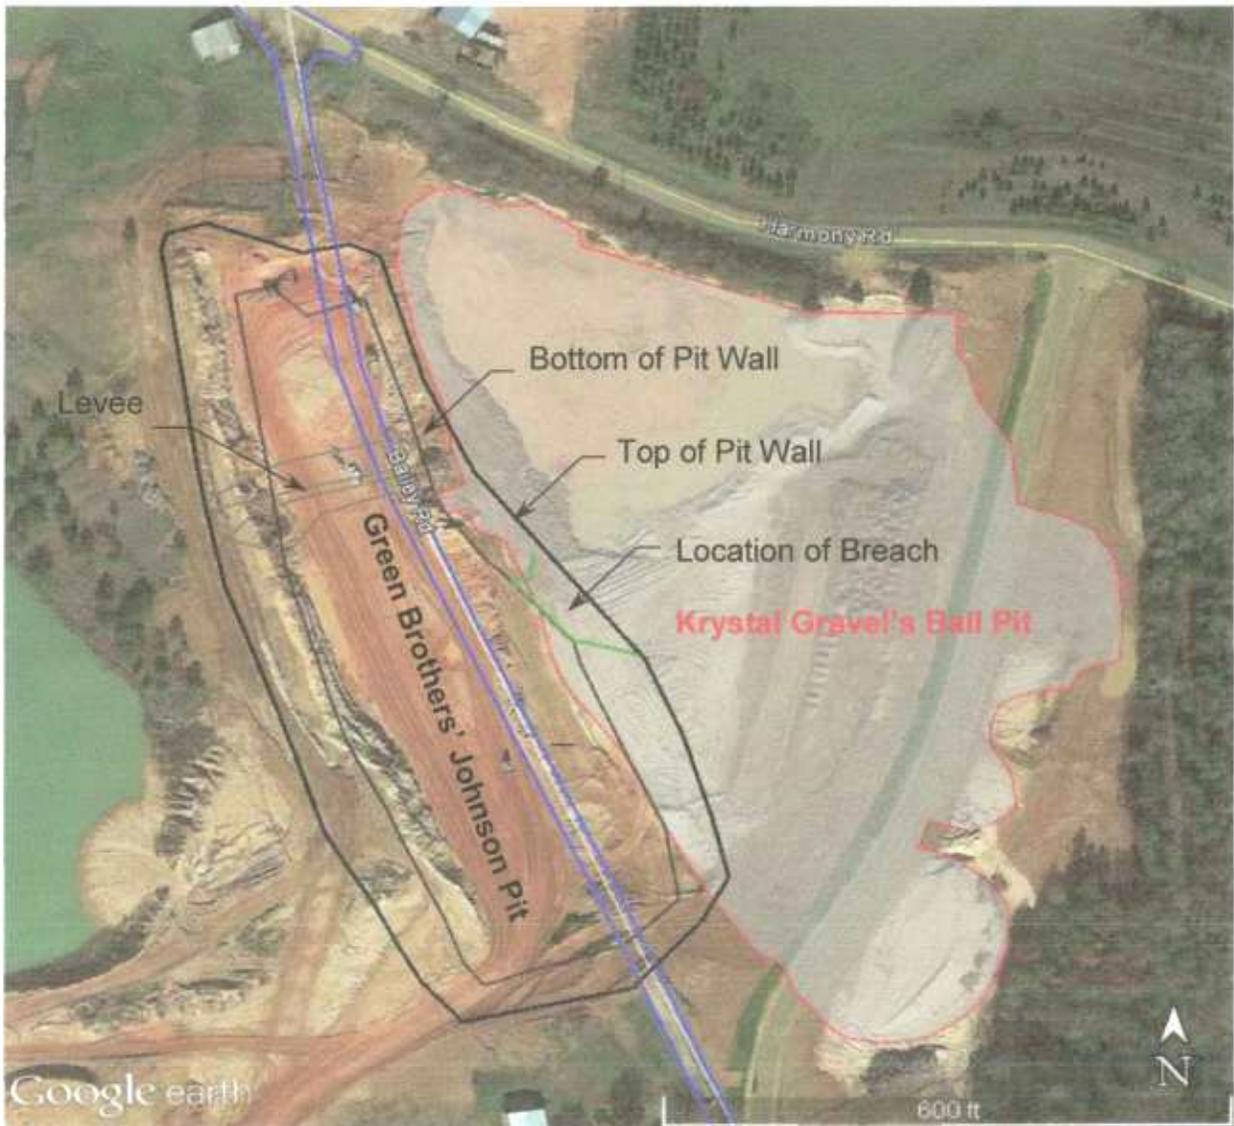
The failure zone was located between 350 and 500 feet north of the south pit wall. The original failure was likely smaller than the final breach dimensions due to the fact that the breach widened by erosion as material flowed through it. The final breach was about 165 feet wide at the top of pit wall and about 84 feet wide along its bottom (Photo 2). The bottom of the breach, which appears to coincide with the top of the natural sand and gravel deposit, was 35 to 44 feet deep between approximate elevations 428 and 437 feet. Observation of the exposed strata on the northern side of the breach revealed that the east wall contained a relatively thin barrier of natural ground that was estimated to be less than 10 feet wide overlain by a wedge of clay tailings, which was overlain by fill material (Photo 3). Observation of the exposed strata on the southern side of the breach revealed that this portion of the east wall contained natural ground only below the breach bottom, which was overlain mostly by sand tailings except for a few feet of clay tailings near the bottom (Photo 4). On the surface, the sand tailings on the southern side of the breach abruptly transitions to clay tailings on the northern side.

Figure 5 – Location of the Johnson Pit, the breach, and the previous Ball Pit shown on a satellite image dated December 14, 2015, viewed in Google earth.

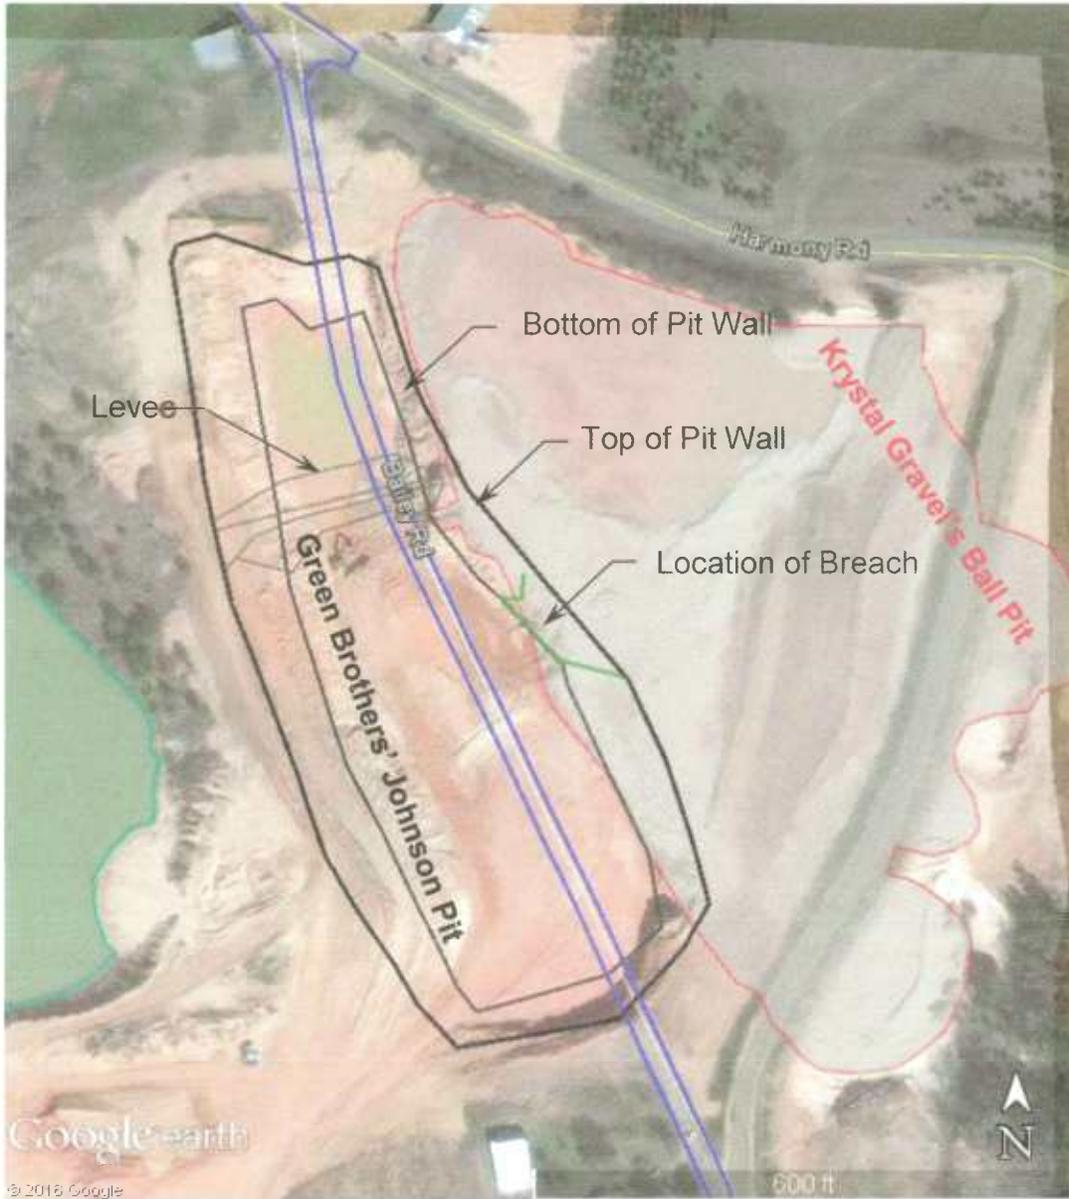
A satellite image obtained from Terraserver.com dated 02/13/2016 shows signs of erosion or other distress on the pit slope where the failure occurred (Figure 6). At that time, there was a pool of water along the east end of the impoundment, similar to the Google image dated 12/14/2015. However, the more recent satellite image showed more waste sand had been pushed into the southwest corner of the impoundment covering the clay tailings, as reported. This image also shows an erosion gully near the northern end of the pit prior to the construction of the levee, and water pooling in the pit.

Figure 7 – Overlay of an aerial image from TerraServer date February 13, 2016, on the satellite image dated December 14, 2015, viewed in Google earth.
