.FINAL REPORT OF MAJOR MINE-EXPLOSION DISASTER ROBENA NO. 3 MINE

UNITED STATES STEEL CORPORATION

COAL DIVISION, FRICK DISTRICT CARMICHAELS, GREENE COUNTY, PENNSYLVANIA

December 6, 1962

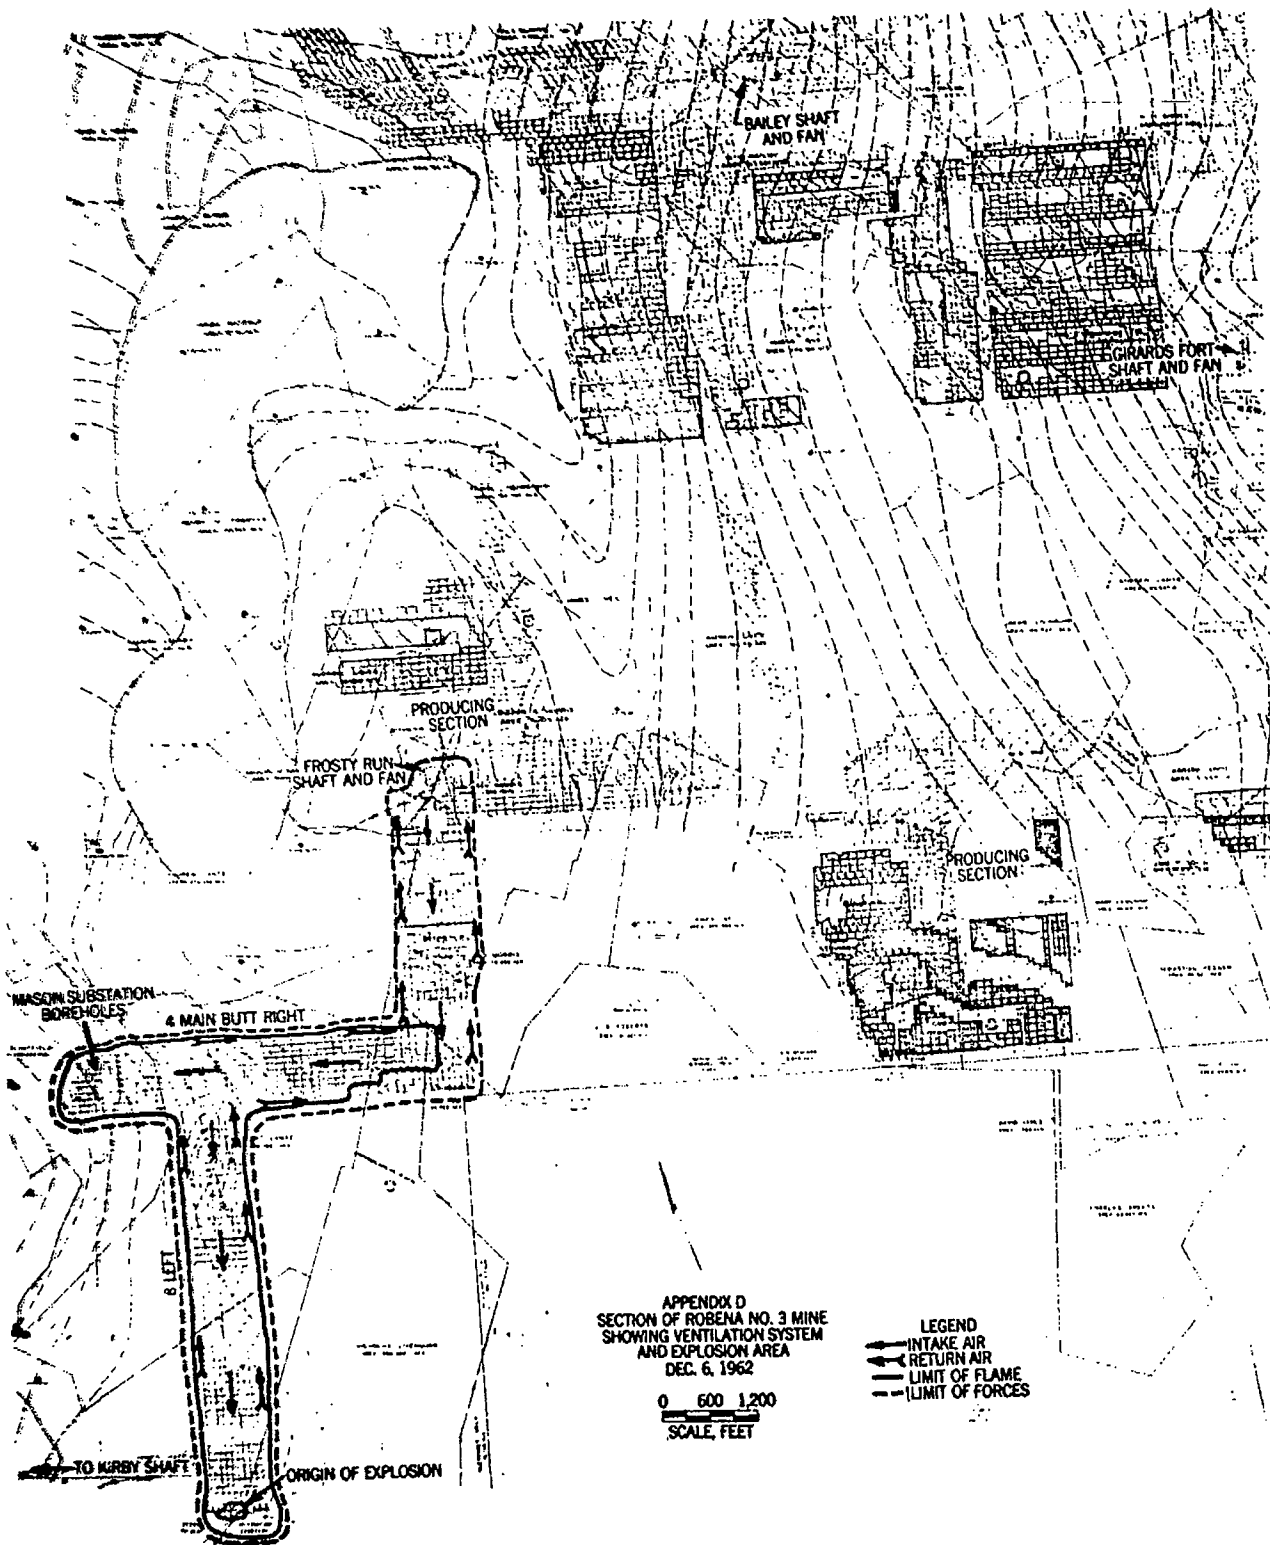
## Appendix G

### Analysis, Frosty Run Fan Operating Chart

Summary - The fan chart indicates that two separate explosions occurred within the mine, approximately 20 to 25 minutes apart. Both explosions exerted sufficient energy acting on the mine ventilation resistance to cause a marked reduction of water gage at the fan. The reduced operating-pressure protective device functioned and stopped the fan in both cases. Neither explosion, although evidenced on the surface by dust clouds emanating from the intake side of the Frosty Run shaft, was sufficiently violent to force open the explosion protective cover plate on top of the return shaft. The first explosion created sufficient permanent change in the underground ventilating system to reduce the normal fan operating pressure from 6.2 inches normal operation to 5.8 inches after the fan was restarted. The second explosion, obviously more violent, reduced the water gage from the previous 5.8 inches to 5.5 inches, as shown after the fan was restarted and remained in operation. There was no evident damage to the fan or protective devices by either explosion as shown by the fan having been started on two occasions.

12:55 p.m.	Fan operating normal, average water gage reading 6.2 inches.
12:55 - 1:15 p.m.	Fan water gage dropped from 6.2 to an average of 0.3 inches, fluctuating both above and below the zero line of the fan chart until the protective reduced pressure switch shut off the fan. This fluctuation was caused as the result of action of explosion forces within the mine. The fan remained idle for approximately 15 minutes.
1:15 - 1:25 p.m.	The fan was restarted at approximately 1:15 p.m. Lines on the chart indicate that the fan did not immediately find its stable operating point then settled with a variation of 0.6 inches water gage, average water gage reading of 5.8 inches. This reduced water gage of 0.4 inches below normal indicates a definite abrupt reduction in mine resistance, such as short circuits for air travel. The fan operated for approximately 10 minutes.
