Report of Investigation Underground Coal Mine Explosions

**Scotia Mine
I.D. No. 15-02055
Scotia Coal Company
Ovenfork,
Letcher County,
Kentucky**

March 9 and 11, 1976

Release Date: August 11, 1993

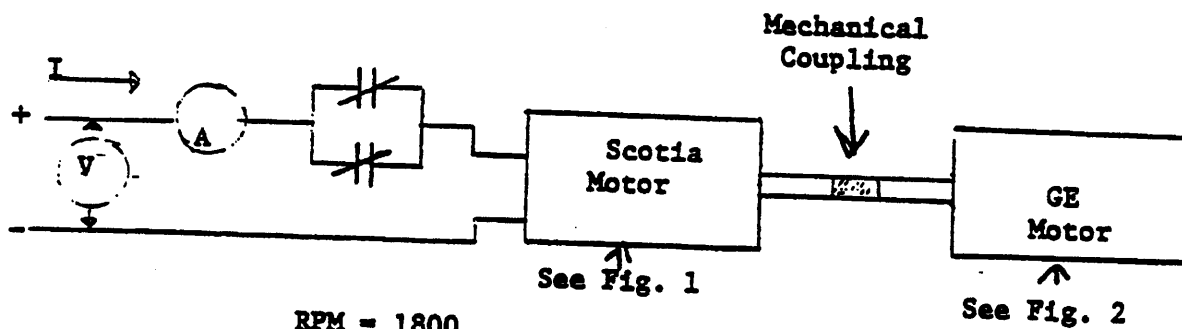
Figure 4

The pressure switch was added per Figure 4. During dry run tests arcing was easily detected at the contacts of the pressure switch when opened under load. Although an ignition was readily predictable, a test in a 7% methane-air mixture was made and an ignition occurred on the first energization of the motor. No further tests were made. Considering the obvious arcing the Scotia motor current was reduced to 7.5 amps at 90 volts DC for the above test.

Pressure Switch
130 PSI to Open
