REPORT OF MULTIPLE FATAL COAL MINE ROOF-FALL ACCIDENT

NO. 1 MINE
HILLMAR COAL COMPANY, INCORPORATED
ASHERS FORK, CLAY COUNTY, KENTUCKY

July 16, 1971

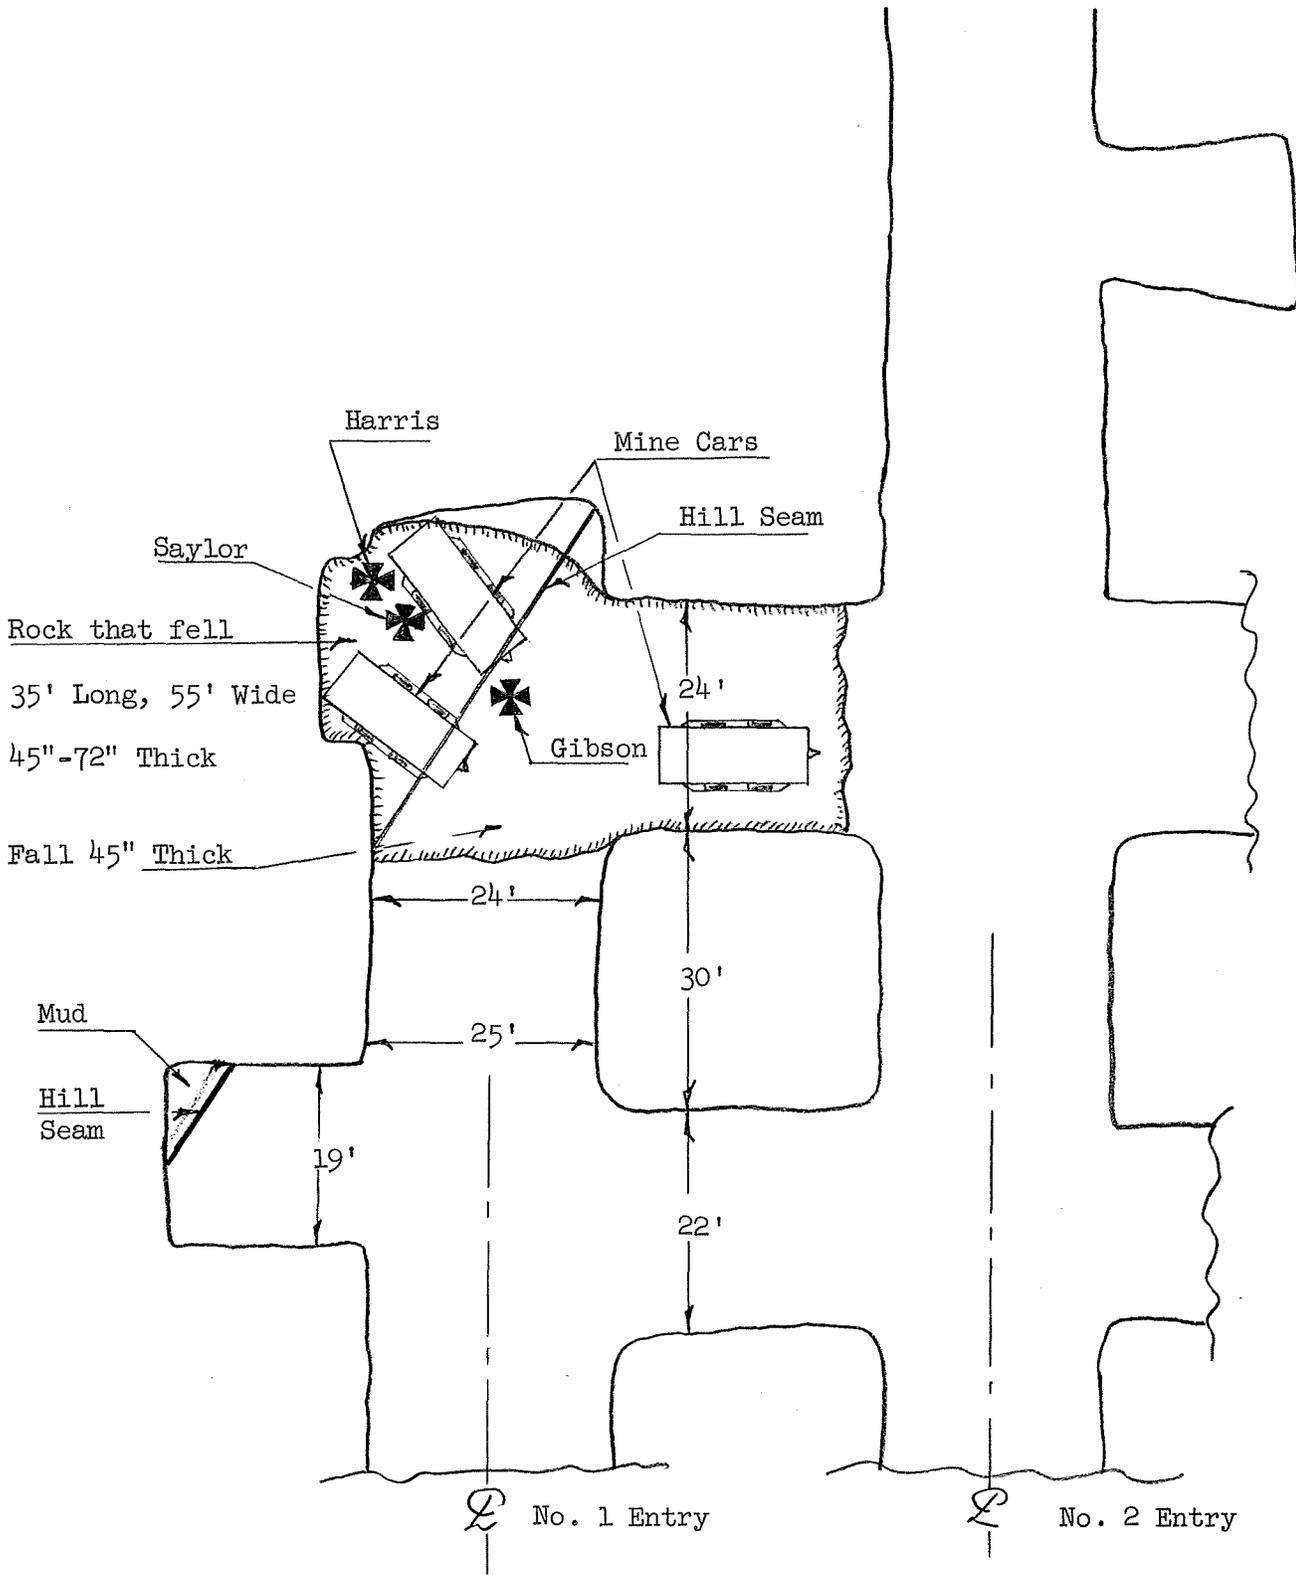
MULTIPLE FATAL ROOF FALL ACCIDENT
 NO. 1 MINE
 HILLMAR COAL COMPANY, INCORPORATED
 ASHERS FORK, CLAY COUNTY, KENTUCKY

Scale: 1"=20'-0"
 Ht. of Coal 40"

A series of three consecutive roof falls beginning at about 2:45 p.m., Friday, July 16, 1971, near the face of No. 1 entry, 1 left section, resulted in the death of three employees and the injury of three other employees. The names of the victims are recorded in Appendix A of this report.

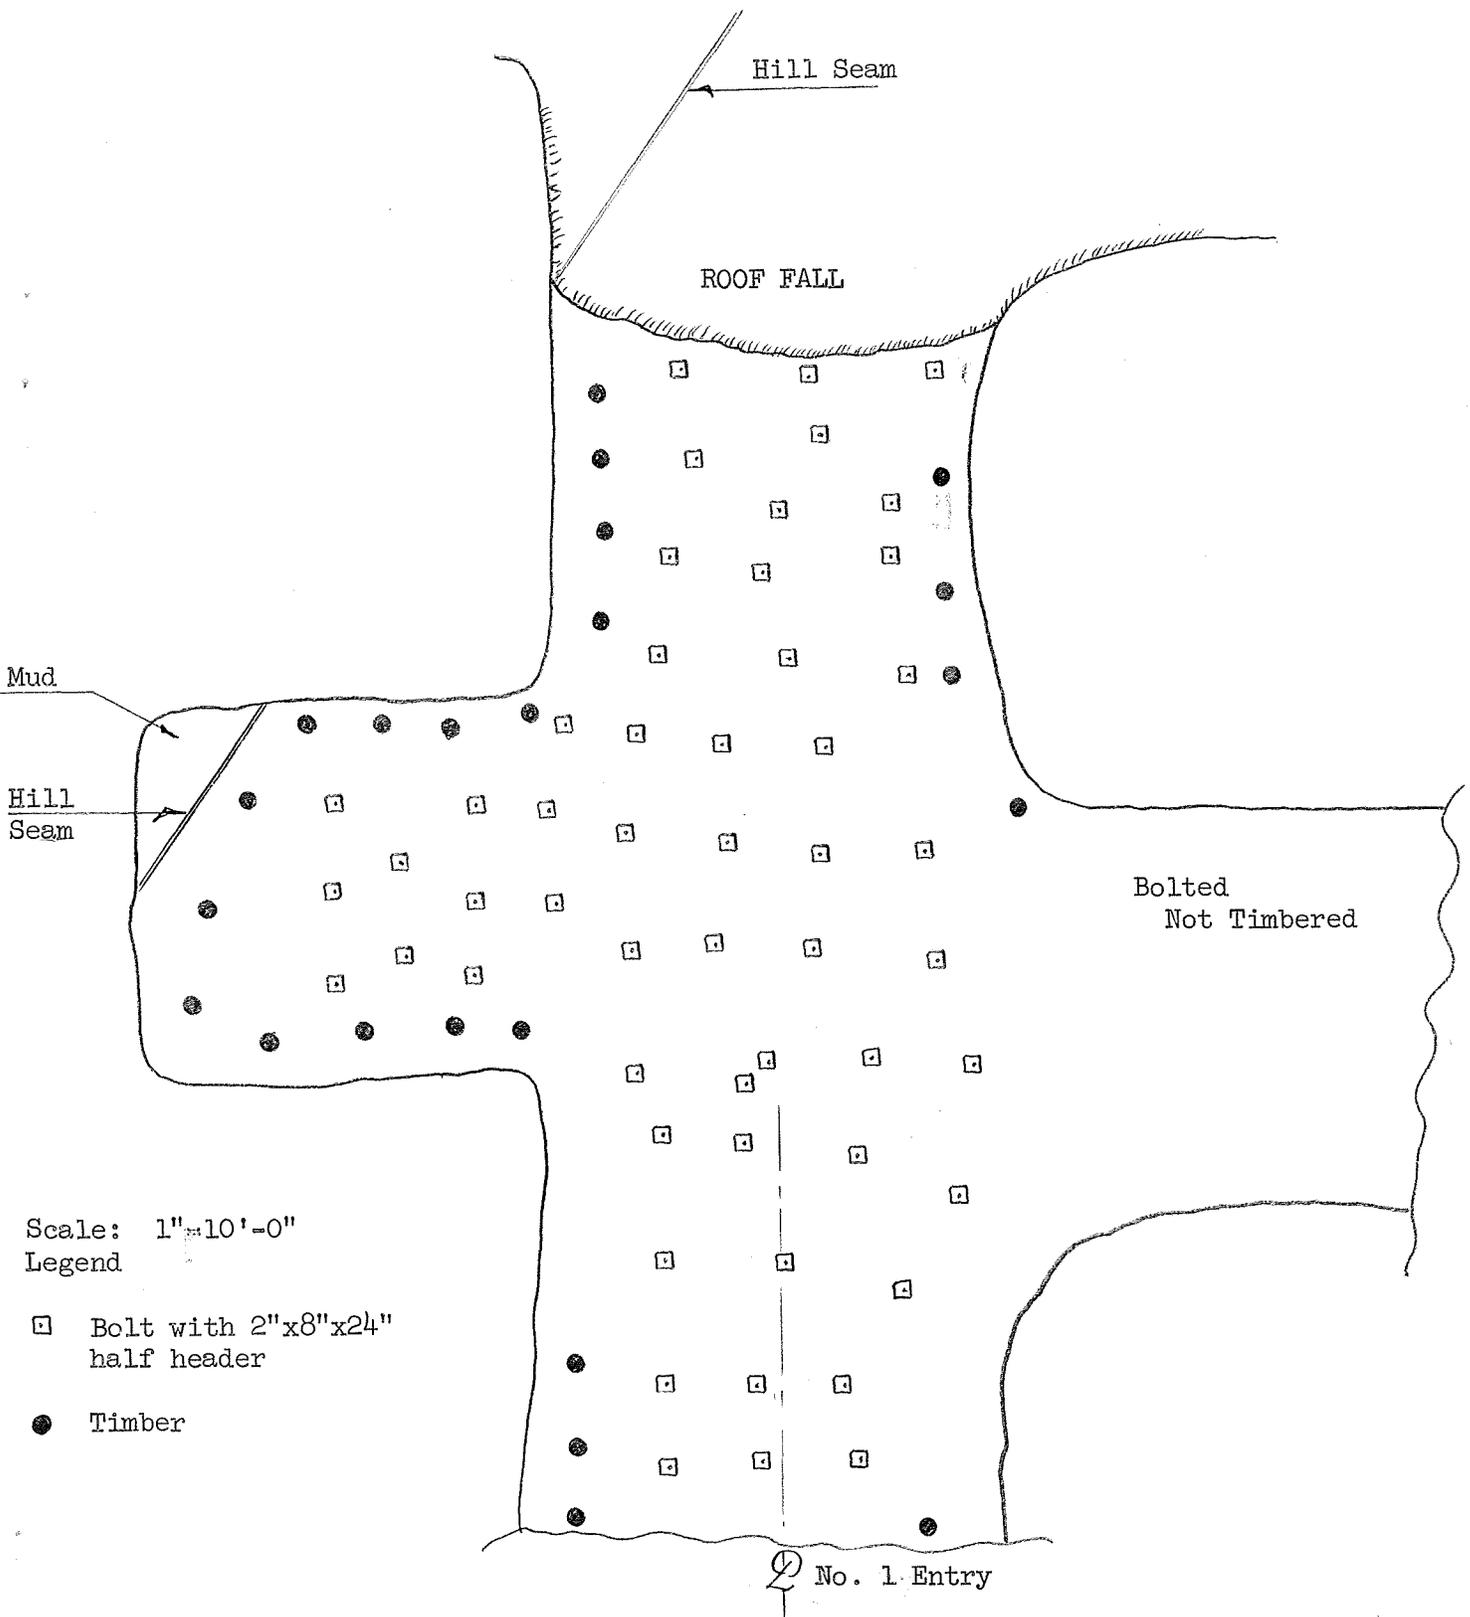
MULTIPLE FATAL ROOF FALL ACCIDENT
NO. 1 MINE
HILLMAR COAL COMPANY, INCORPORATED
ASHERS FORK, CLAY COUNTY, KENTUCKY

Scale: 1"=10'-0"
Legend

- Bolt with 2"x8"x24"
half header
- Timber

A roof-support plan was submitted May 5, 1970, and approved with a modification July 8, 1970. The roof-support plan, if followed, is satisfactory under normal conditions; however, where abnormal conditions, such as hill seams, development beneath hollows and proximity to the surface are encountered, additional means beyond the minimum plan are to be taken to provide adequate protection for the roof.

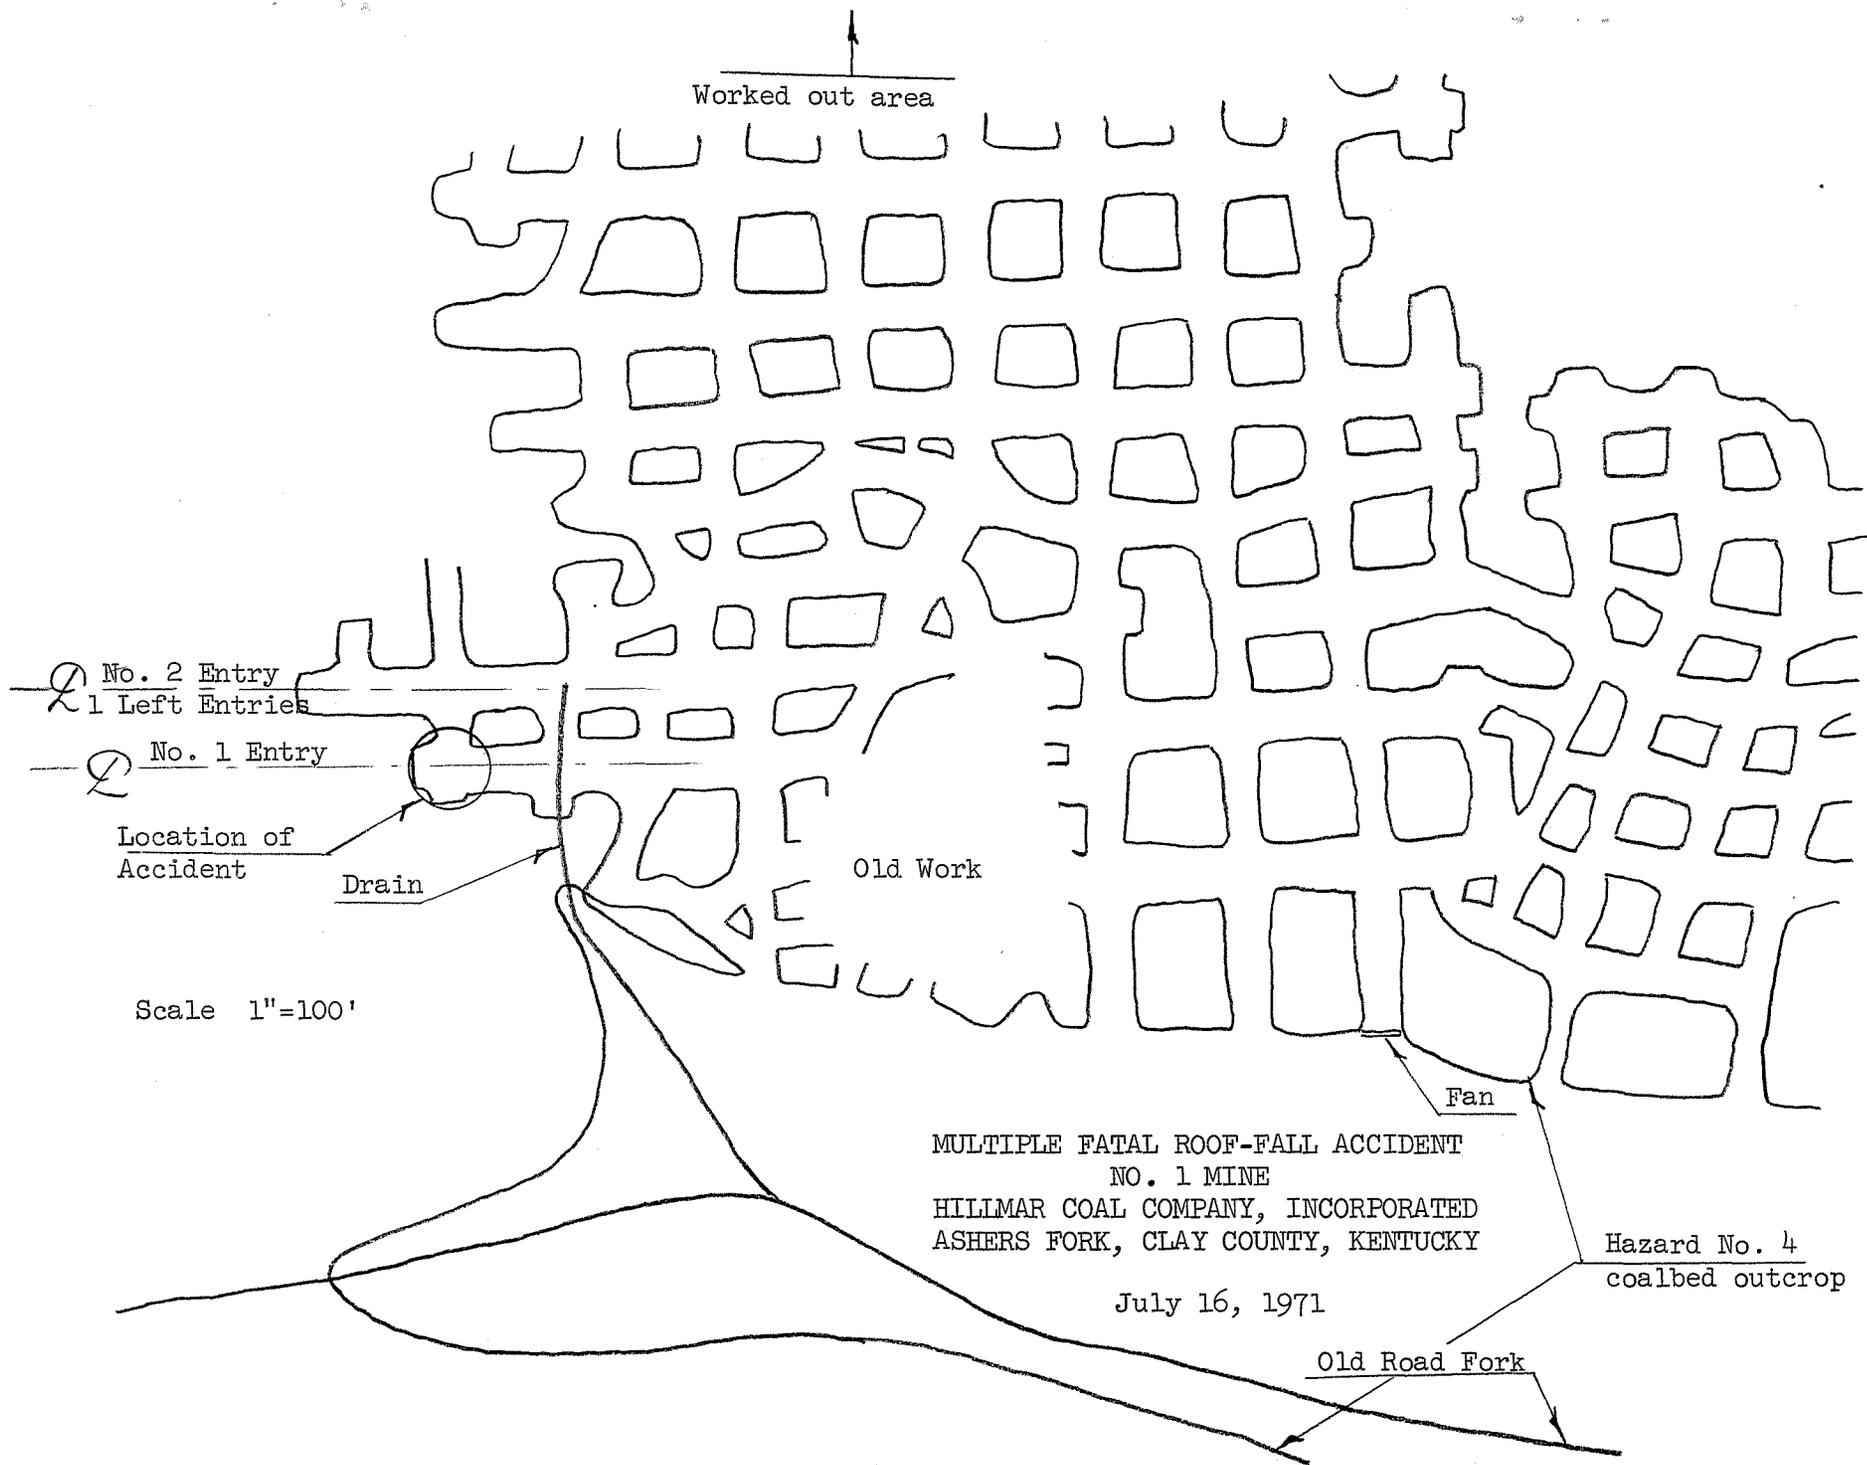
Worked out area

No. 2 Entry
1 Left Entries

Hazard No. 4
coalbed outcrop

4. When mining is done near the outcrop or when hill seams or other abnormal roof conditions are encountered, the roof-support system shall be revised by driving the places no wider than necessary to safely accommodate the equipment and by installing additional support, or the area abandoned.
